INSTALLATION OF A SELF-SEALING MATERIALS
SYSTEM IN A C-130 INTEGRAL FUEL TANK WING

R. M. Heitz
F. Hill

Northrop Corporation
Aircraft Division

TECHNICAL REPORT AFML-TR-72-30

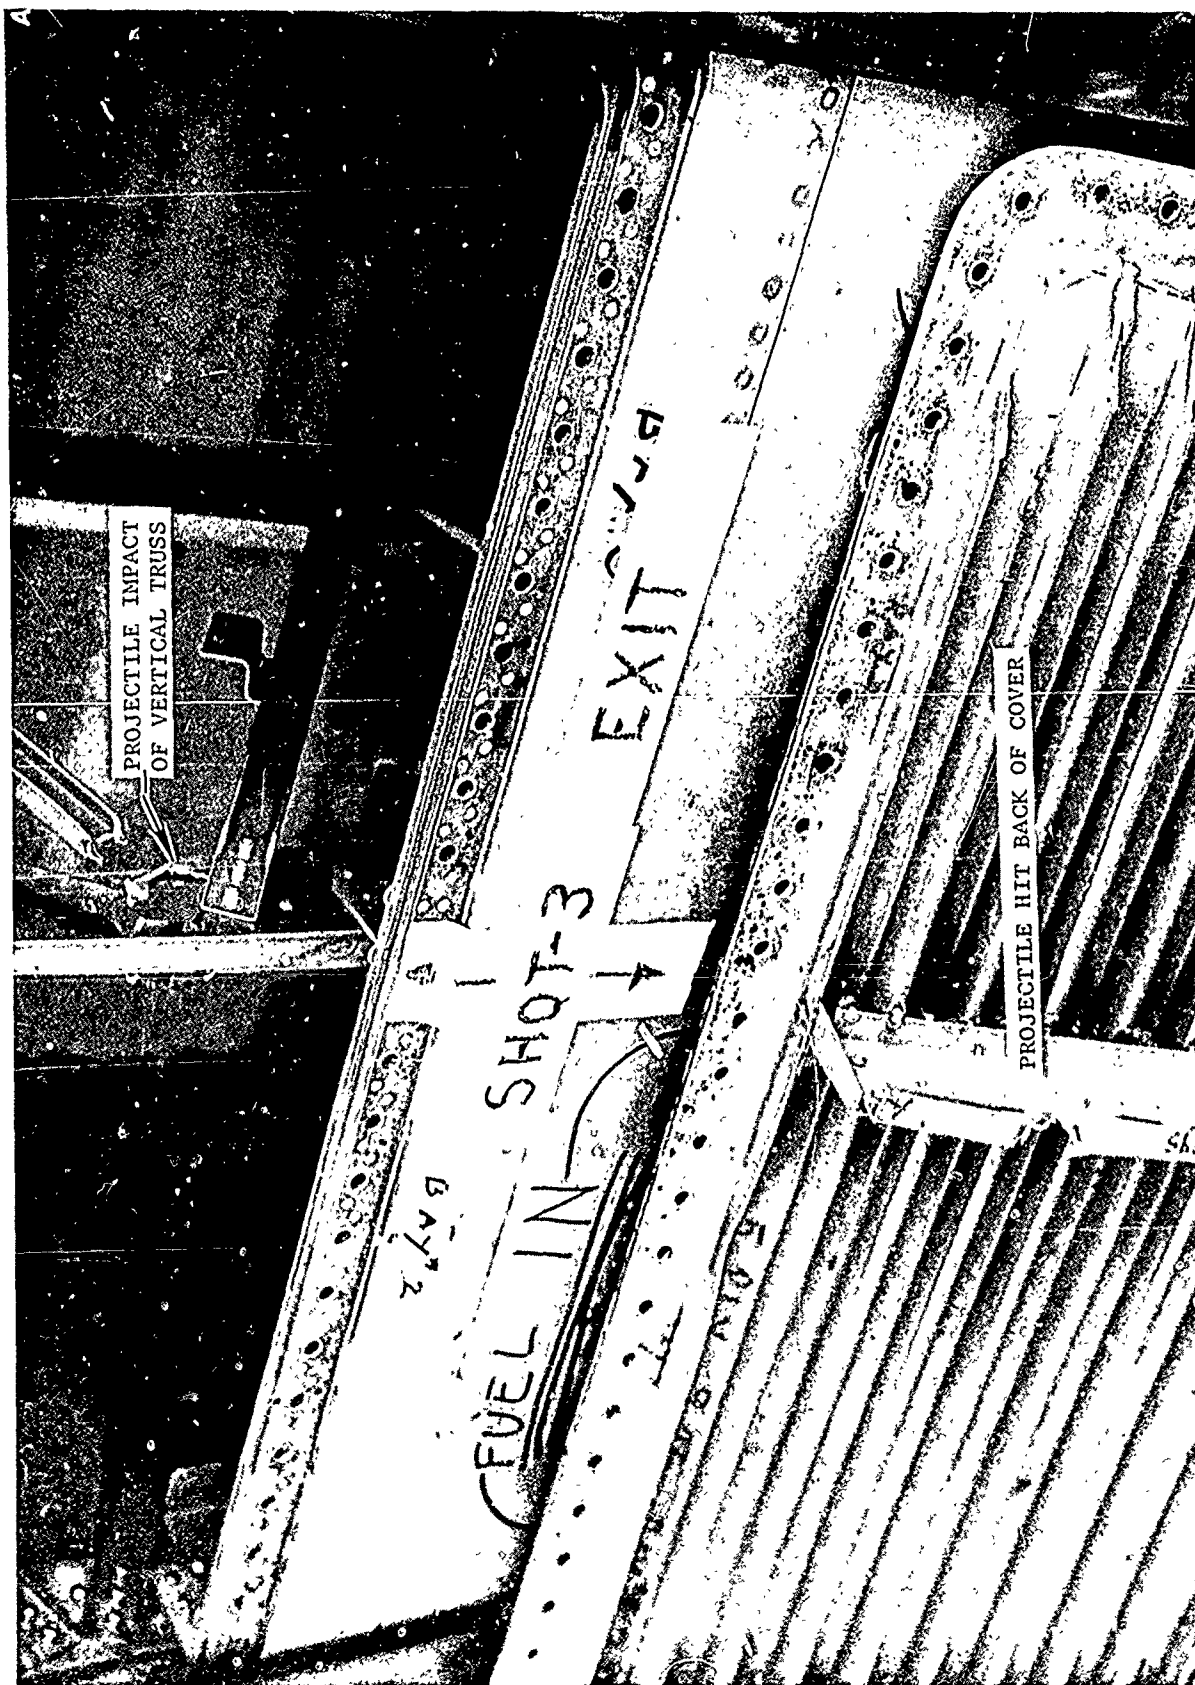
FIGURE 54. TEST NO. 3, .50 CALIBER AP, 45° FROM VERTICAL -
IMPACT OF PROJECTILE NEAR EXIT FACE OF TANK

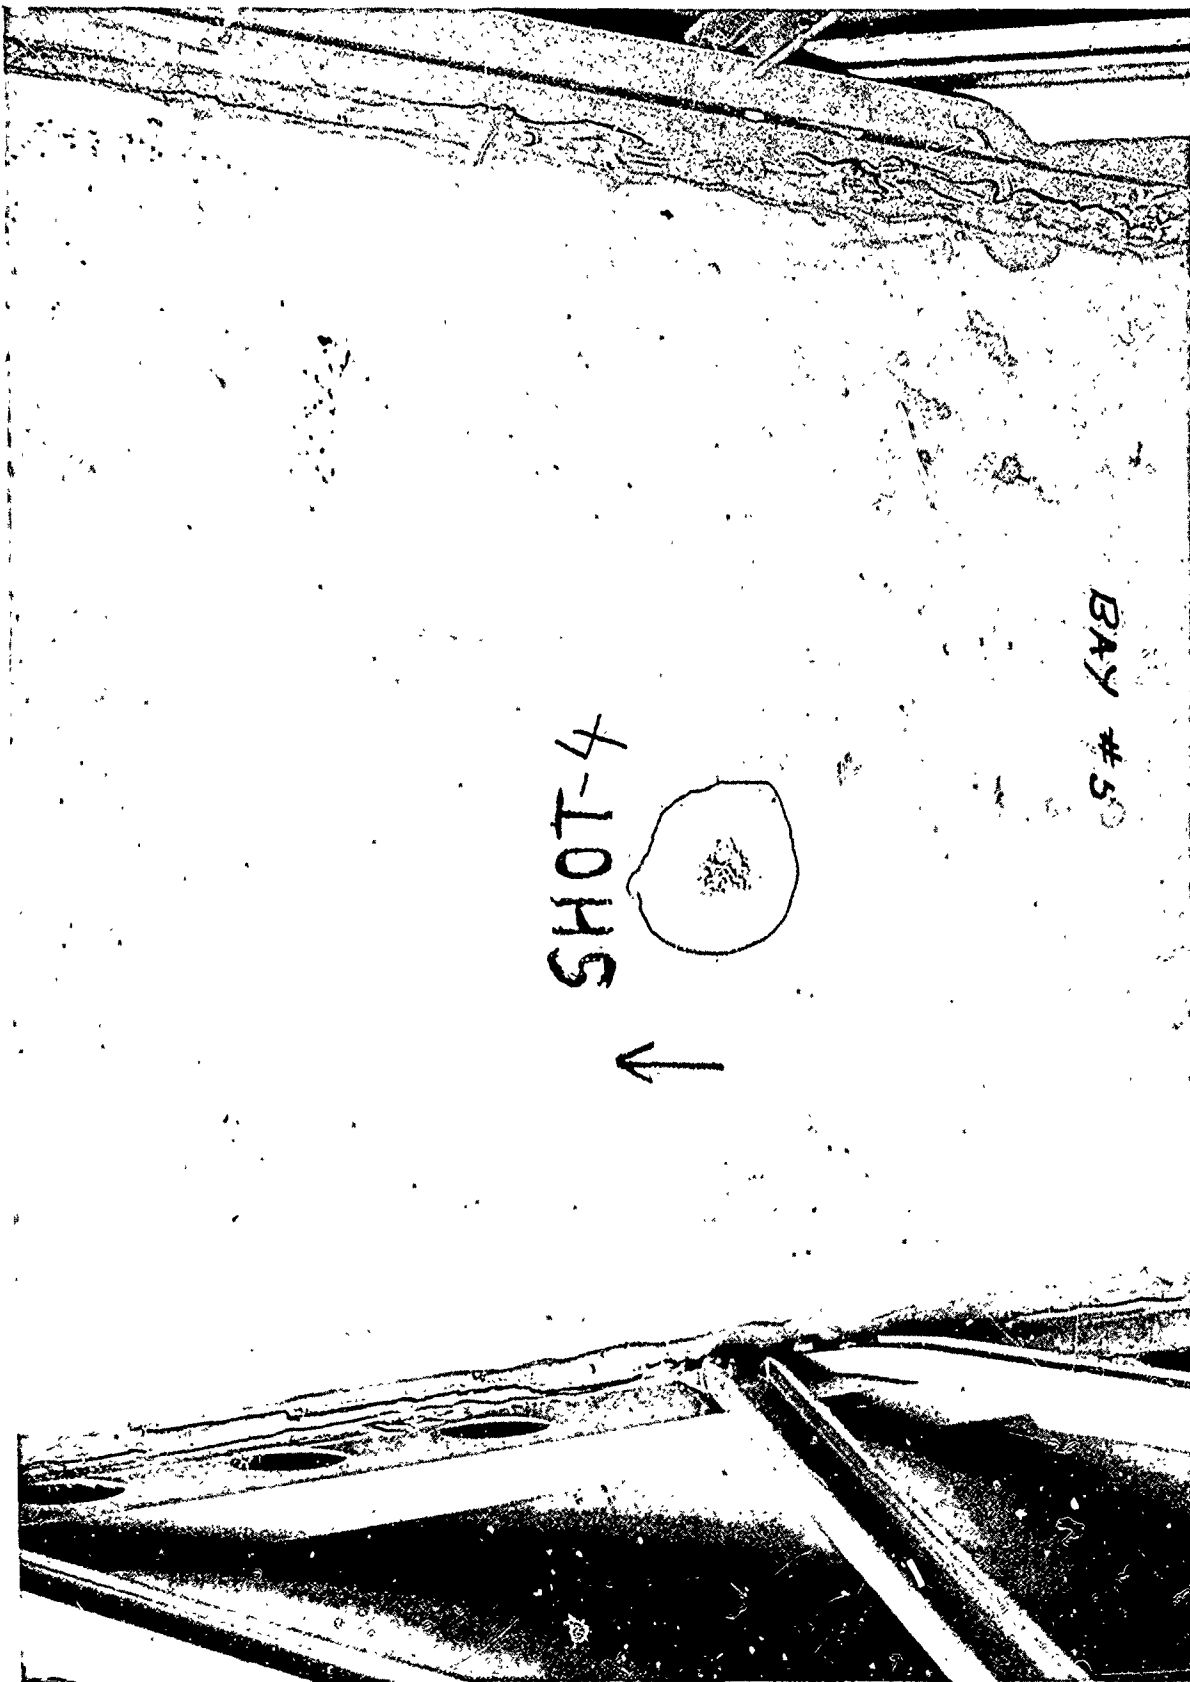
FIGURE 56. TEST NO. 4, .50 CALIBER AP, 45° FROM VERTICAL -
PLAIN LAMINATE BEHIND THE ENTRY WALL

At entry, the projectile hit a rib laterally and ruptured it. Some deformation occurred at the entry hole due to the 45° angle impact (see Figure 55). The plain laminate behind the entry wall showed minor damage as is illustrated in Figure 56. The leakage measured was approximately 130 cc/min. This leakage reduced to about 70 cc/min. about 45 minutes after the shot. At the exit side of the tank, the projectile hit the metal skin in a slightly tumbled position, ruptured one rib, and bent another. The corrugated

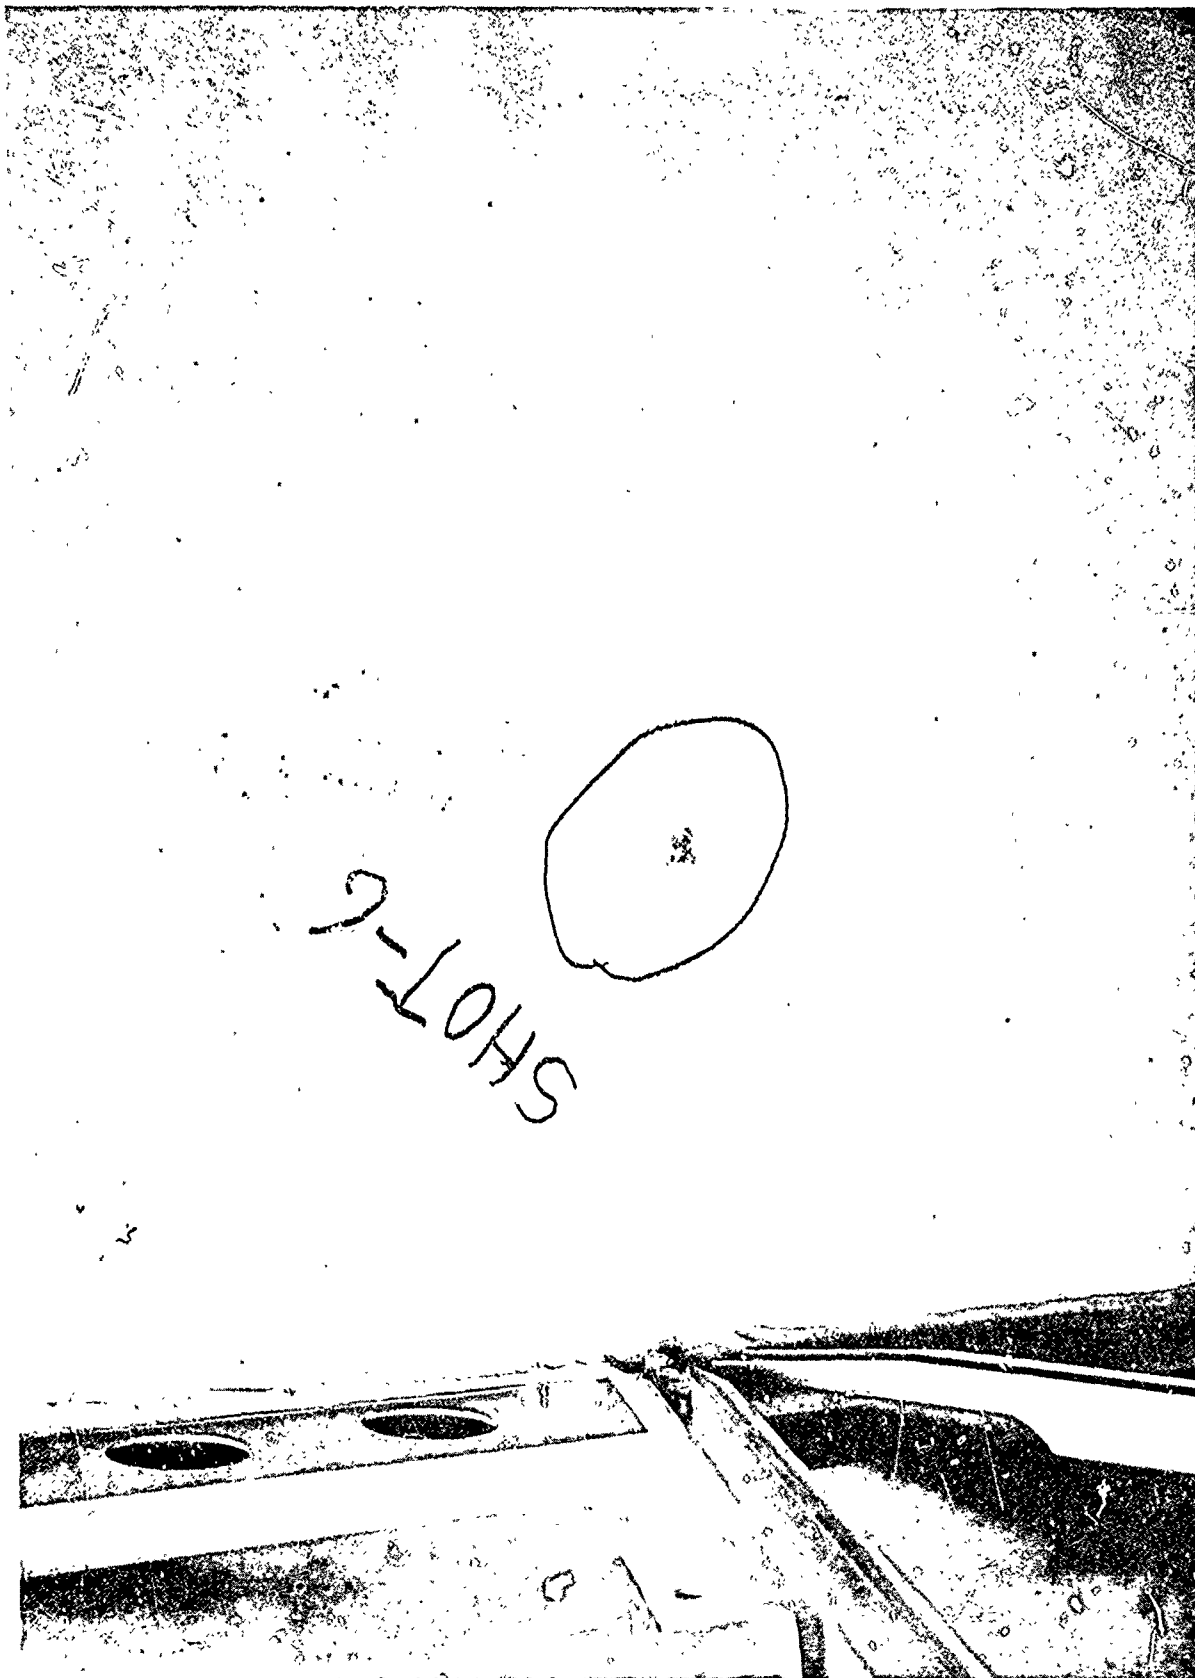
FIGURE 62. TEST NO. 6, .50 CALIBER API, VERTICAL -
PLAIN LAMINATE BEHIND THE ENTRY WALL
